CHEMICAL PROCESS SAFETY

— LEARNING FROM CASE HISTORIES —

ROY E. SANDERS

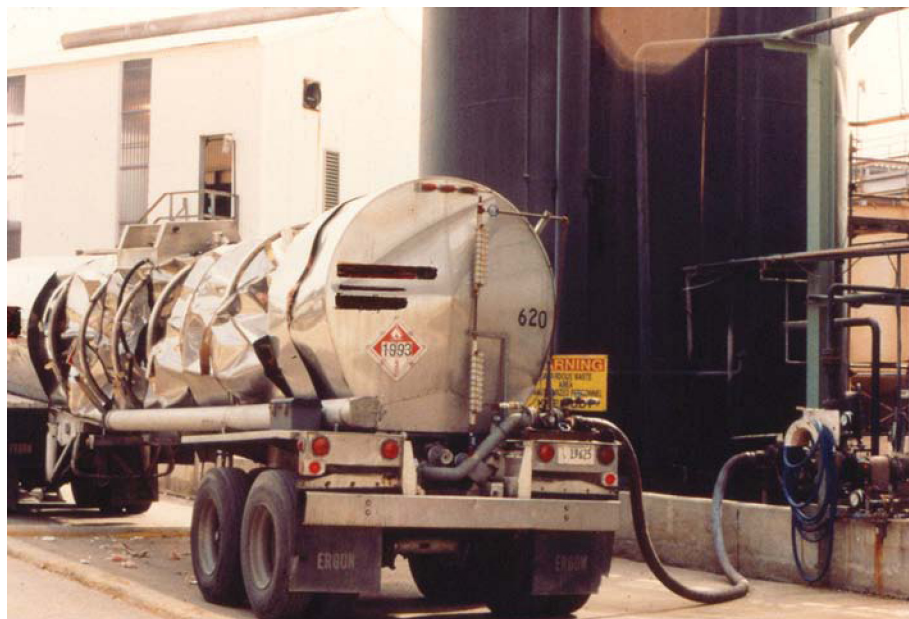
Figure 2.2 Collapsed tank truck with unloading hose connected.

The plant operator opened the nitrogen valves that were both upstream and downstream of the plant's nitrogen pressure regulator to pad the truck. The truck manifold that was in front of the right rear wheels contained a pressure gauge that read the expected 20 psig (1.36 bar). The operator opened the proper liquid delivery valves, started the unloading pump, and left to handle other chores. The driver stayed with the truck, as was the normal procedure.

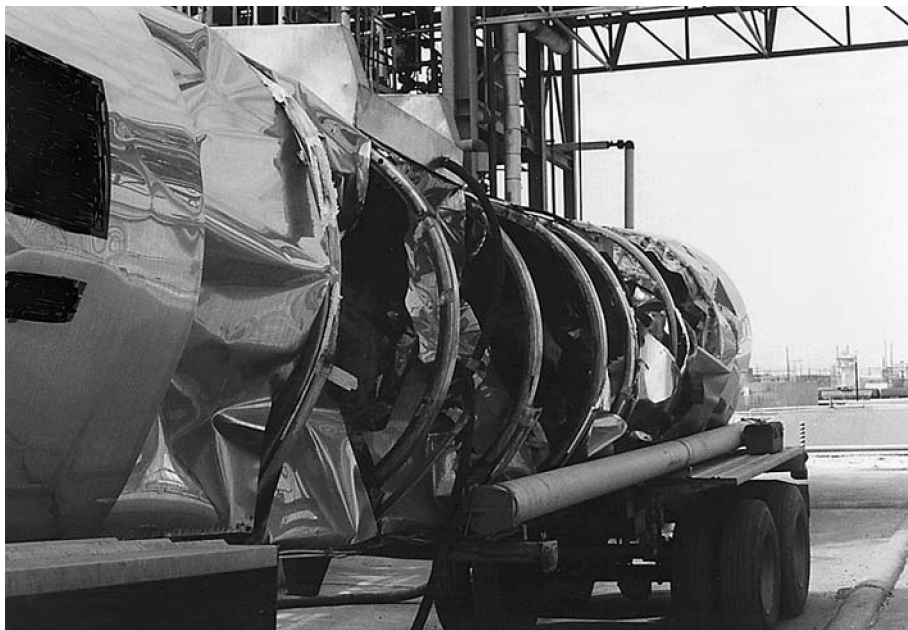
Figure 2.5 Closeup of tank failure and exposed ribs.

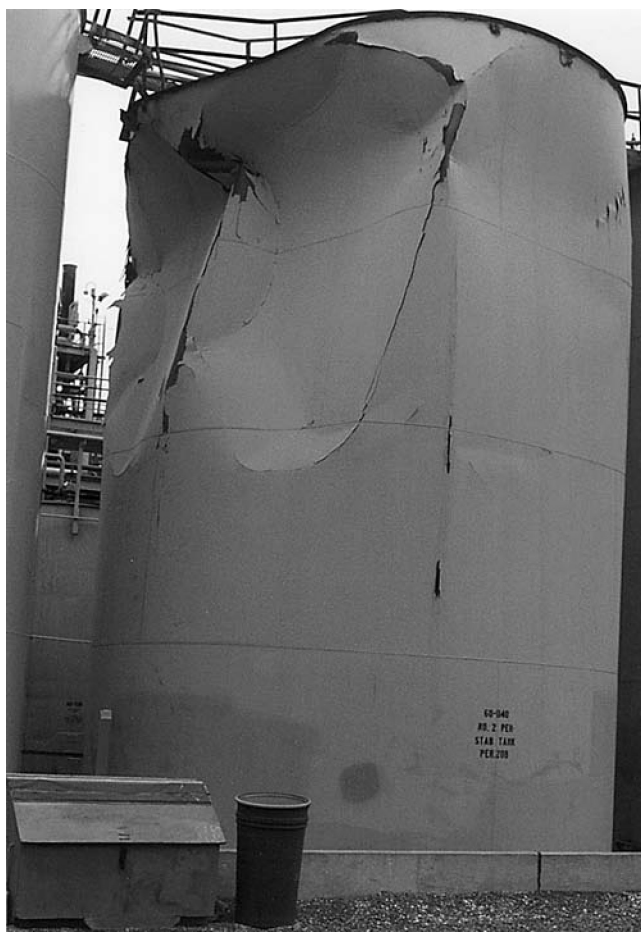
Figure 2.13 A 12-ft.-diameter storage tank ruined after vent system is improved.

The roof and top two courses of 1/4 in. (0.64 cm) thick vertical walls were dramatically sucked in the first time the contents were pumped out following the piping modifications. The tank was filled after it had been out of service, the product was analyzed, and a transfer from the tank was started around 5:30 P.M. The collapsed sections of the tank were observed before sunrise about 6:00 A.M. the next morning (see [Fig. 2.13](#)).

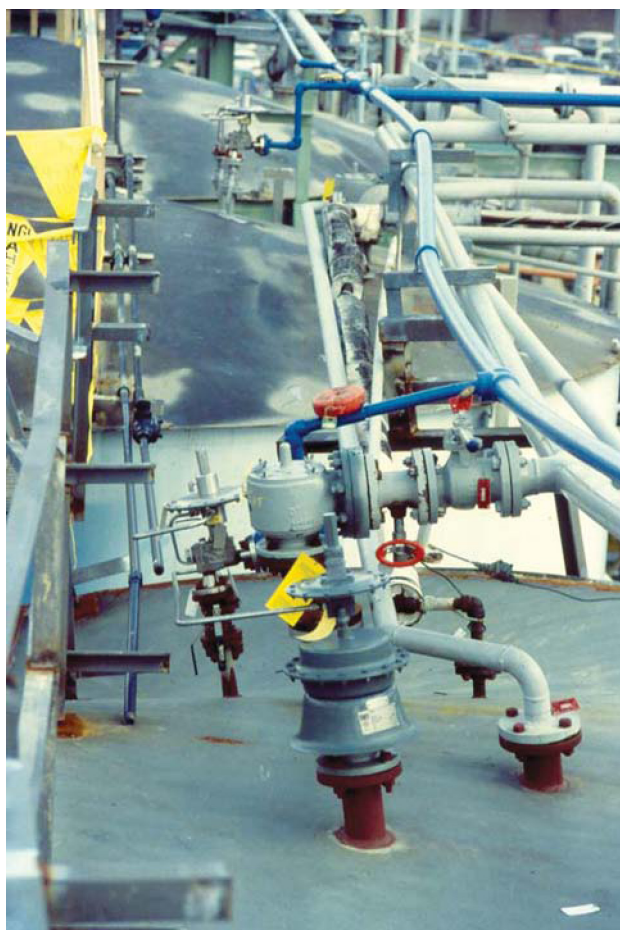
Figure 2.15 Newly installed but visually confusing piping system – after the incident.

A small block valve is usually installed at a tank on any instrument impulse line just in case a leak develops on the small tubing. In this unit block valves are generally avoided on overpressure or vacuum relief devices. If a block valve that can defeat an overpressure device cannot be avoided, such a valve is chained and locked open or car-sealed opened and a protocol is developed to administratively control accidental closing of such a prime safety feature.

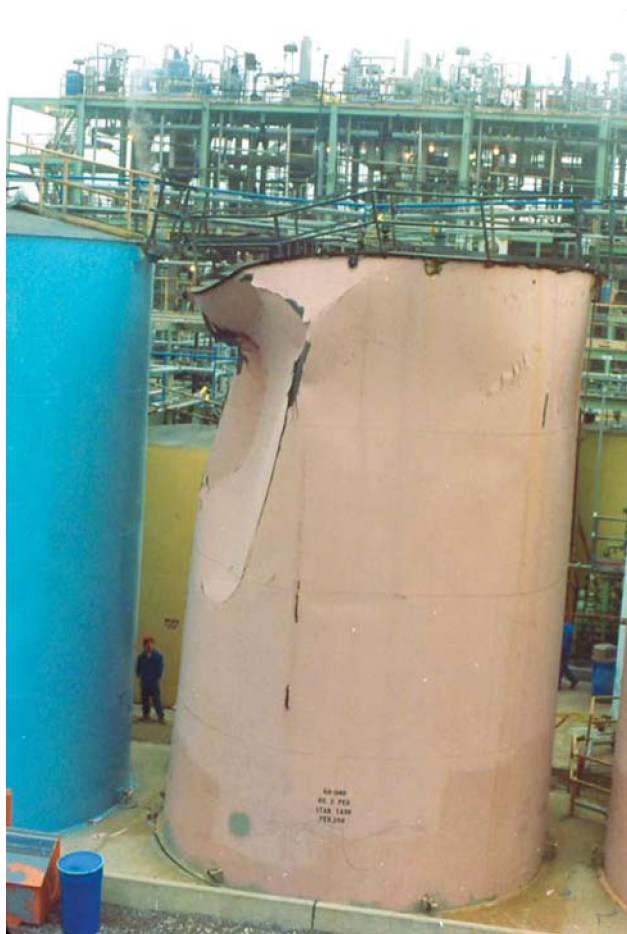
Figure 2.16 Tank collapsed during pump out and was destroyed beyond repair.

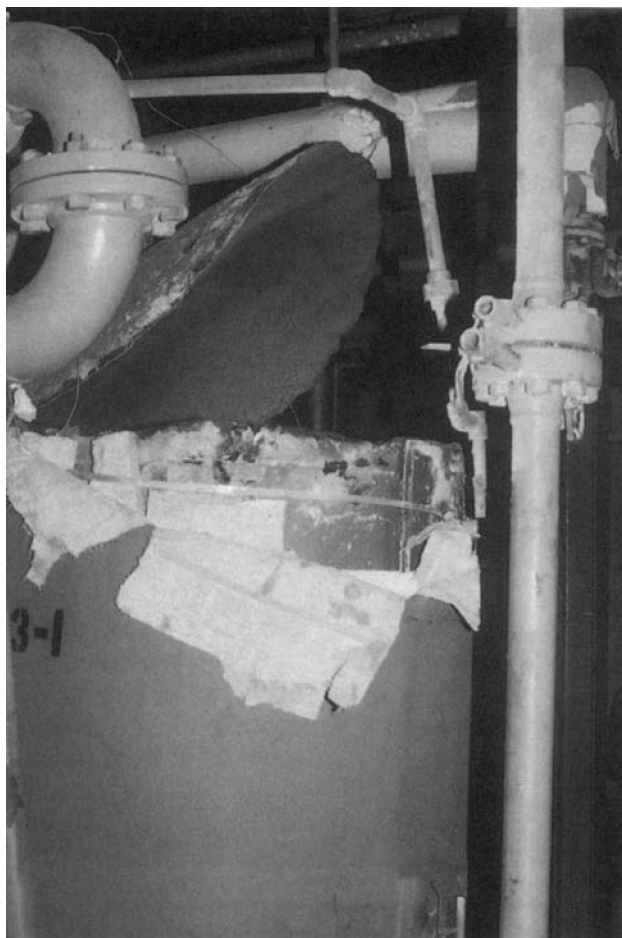
Figure 2.22 Close-up of the failed air dryer.

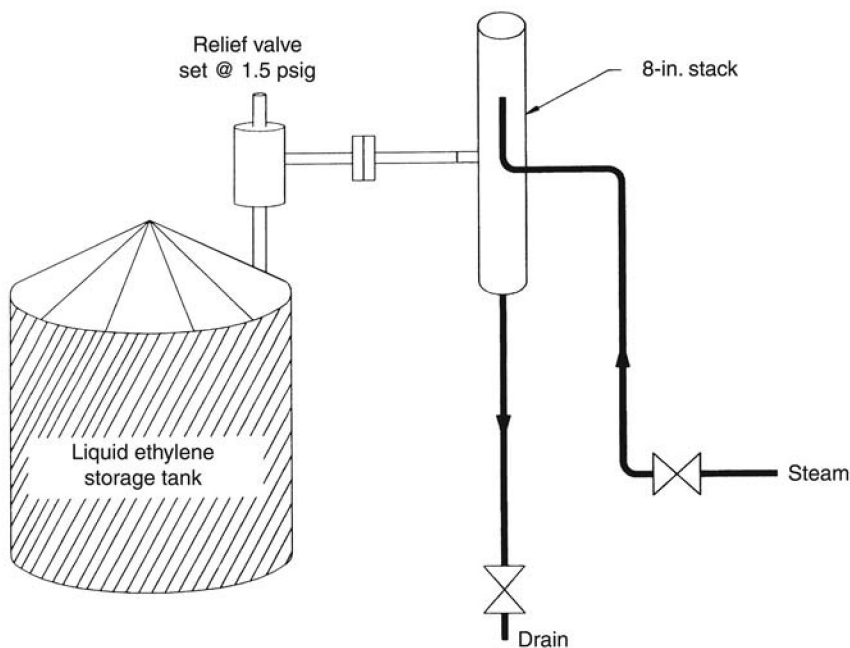
Figure 2.25 Well-intended vent modifications.

The 8 in. (20.3 cm) safety relief valve discharge line had frozen solid. It is easy to understand that hot steam does not stay warm very long when it contacts -155°F (-101°C) ethylene. The steam quickly condensed and then the water froze. No one seemed to anticipate the shortcomings of the original faulty suggestion.

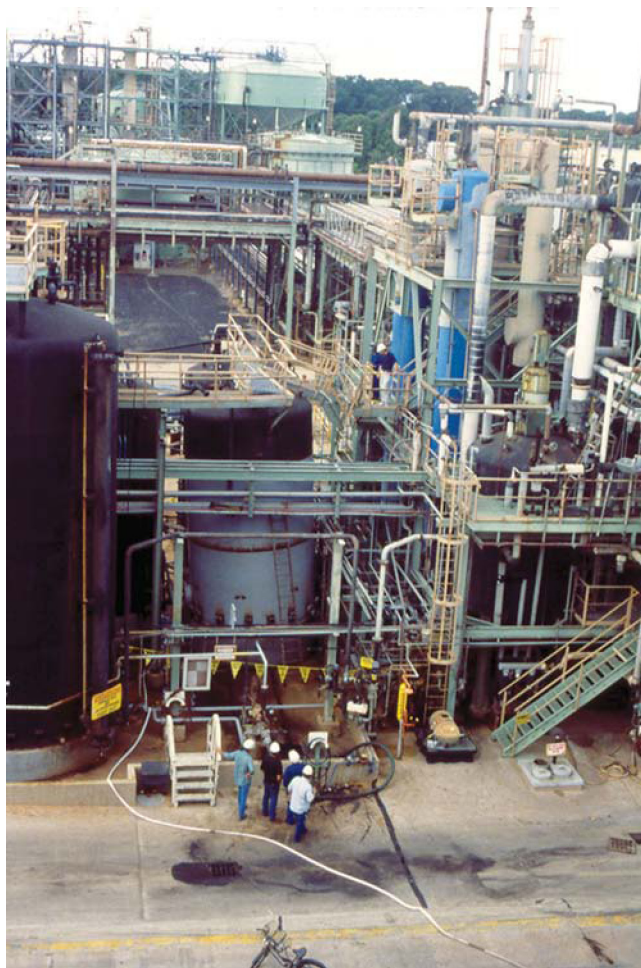
Figure 3.1 An API 620 tank is damaged during a hydro-test that went awry.

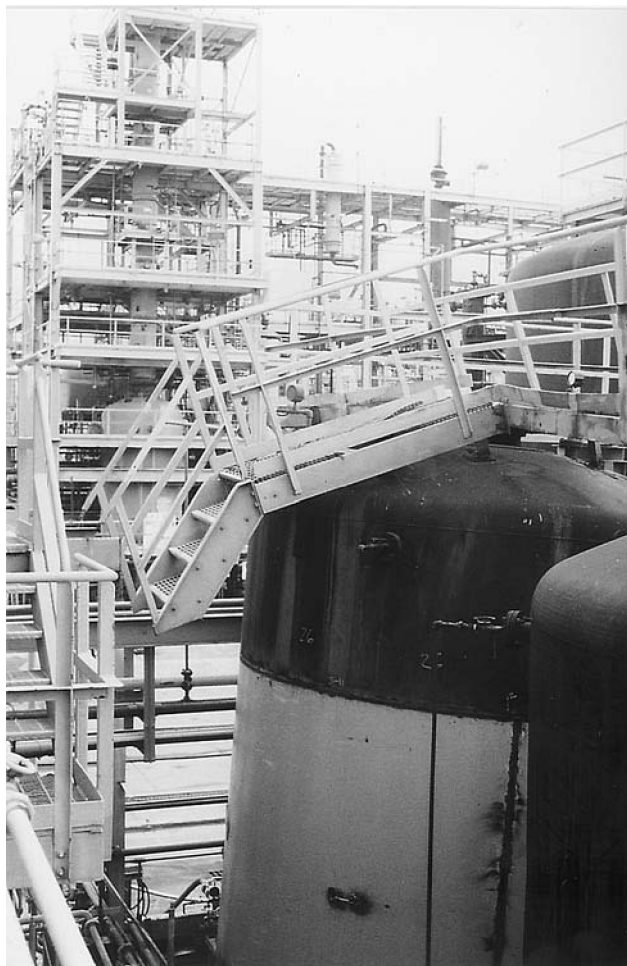
Figure 3.2 A closer look at the slightly leaning tank and the walkway that was torn off during a faulty hydro-test.

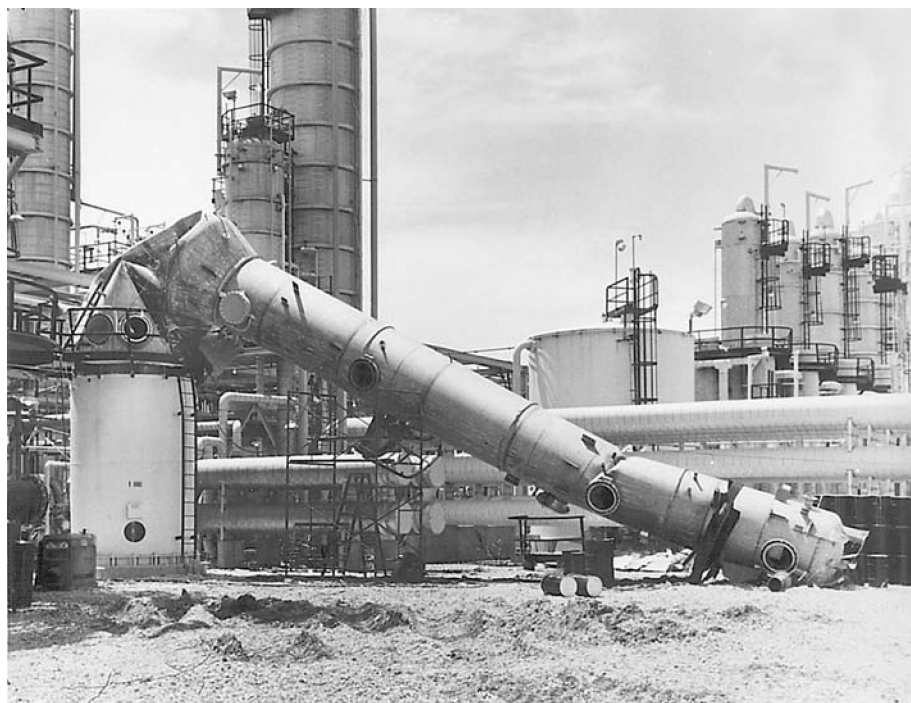
Figure 3.5 A stripper column collapses when water is pumped out.
Courtesy of Guido DeJesus.

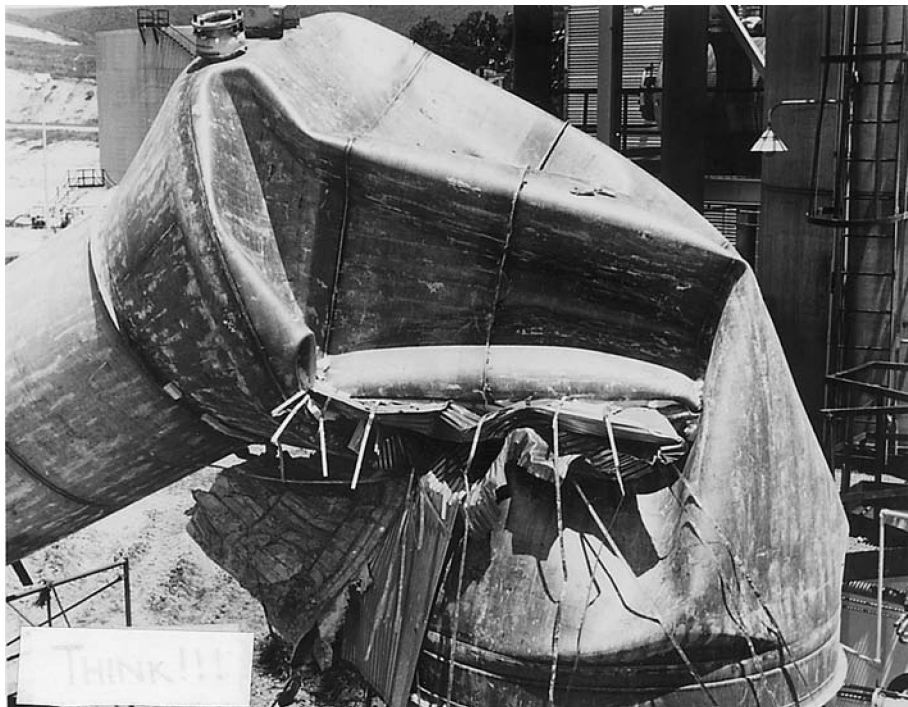
Figure 3.7 A close-up of a collapsed stripper column base.
Courtesy of Guido DeJesus.

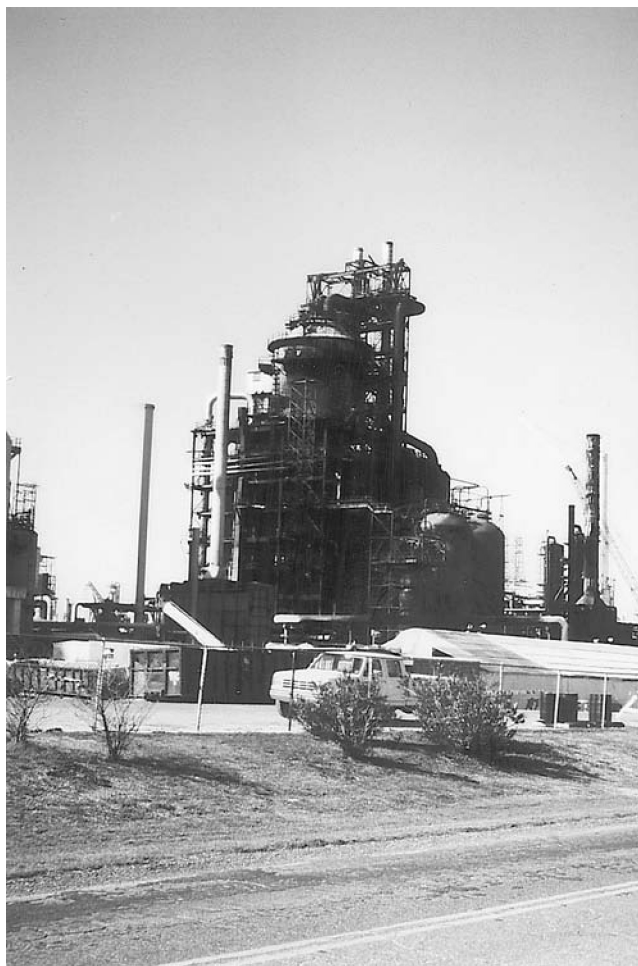
Figure 3.12 After the explosion, a charred multistoried catalytic cracking unit.

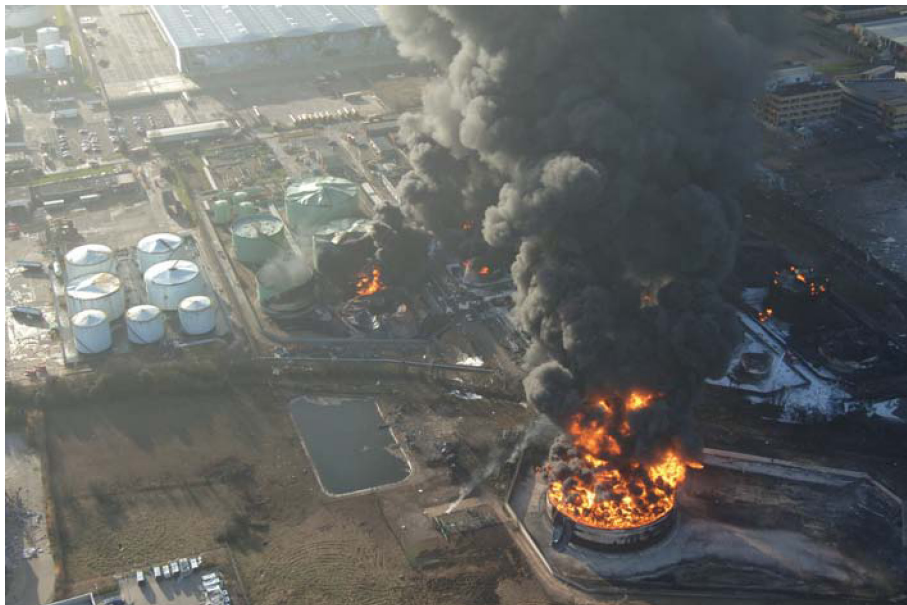
Figure 5.4 Aerial view of the burning fuel tanks in the Buncefield fuel terminal and the nearby commercial buildings. Aerial Photo 6. Courtesy of the Hertfordshire Constabulary.

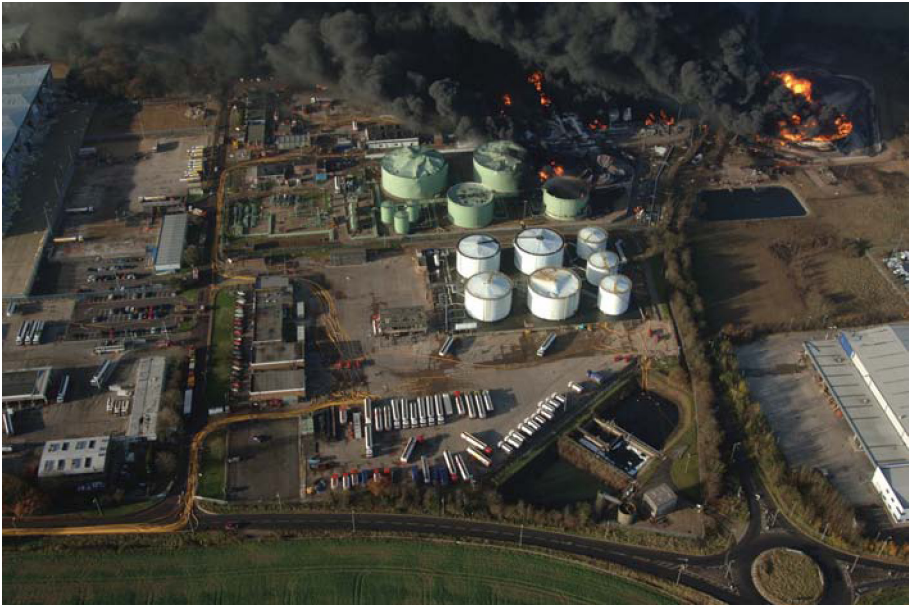
Figure 5.5 Aerial view of the burning tanks in the Buncefield fuel terminal. The commercial buildings on the left side are part of the Maylands Estates. They were badly damaged. Aerial Photo 9.

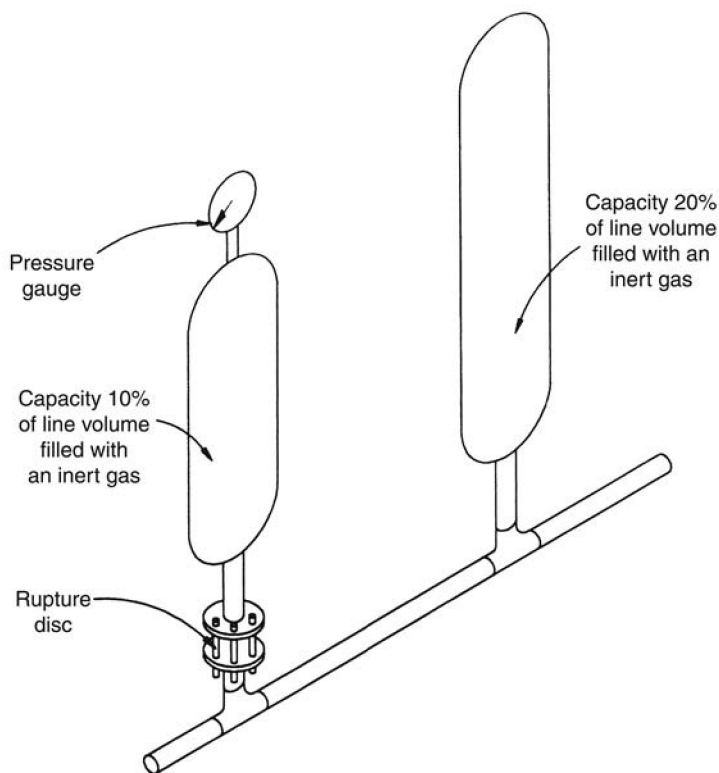
Figure 6.6 Expansion chambers for liquid chlorine pipeline protection. Sketch adapted from Chlorine Institute pamphlets.

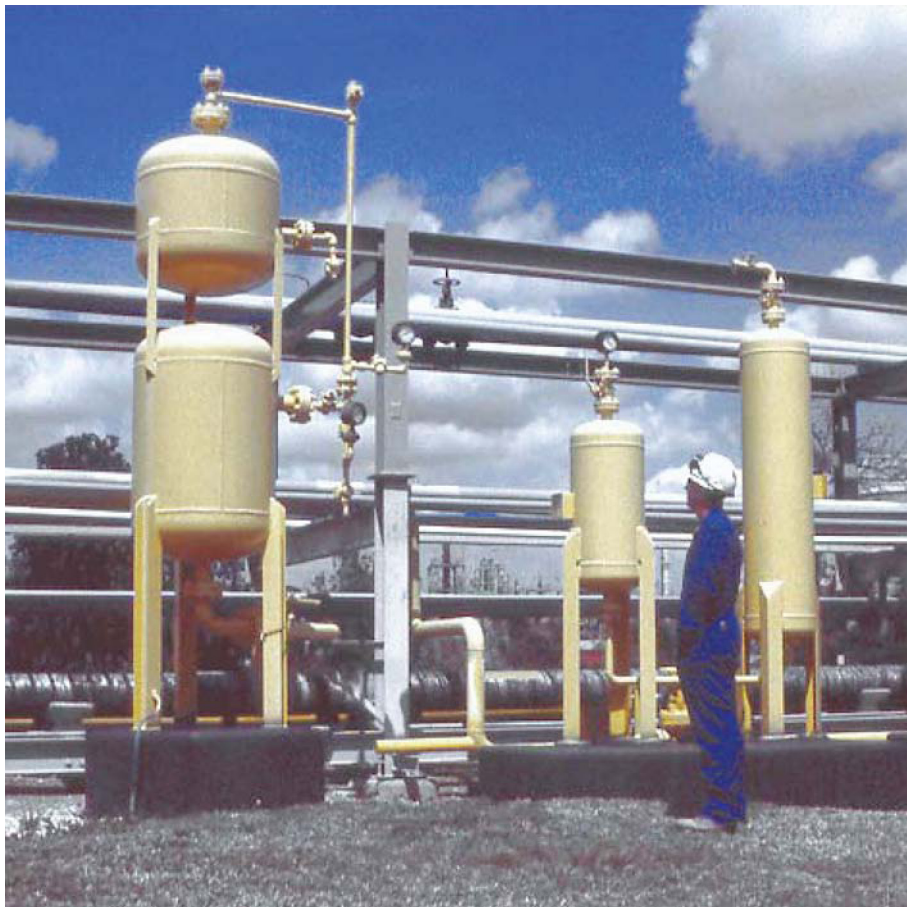
Figure 6.7 An engineer observes the pressure gauges on chlorine expansion bottles protecting liquid chlorine pipelines.

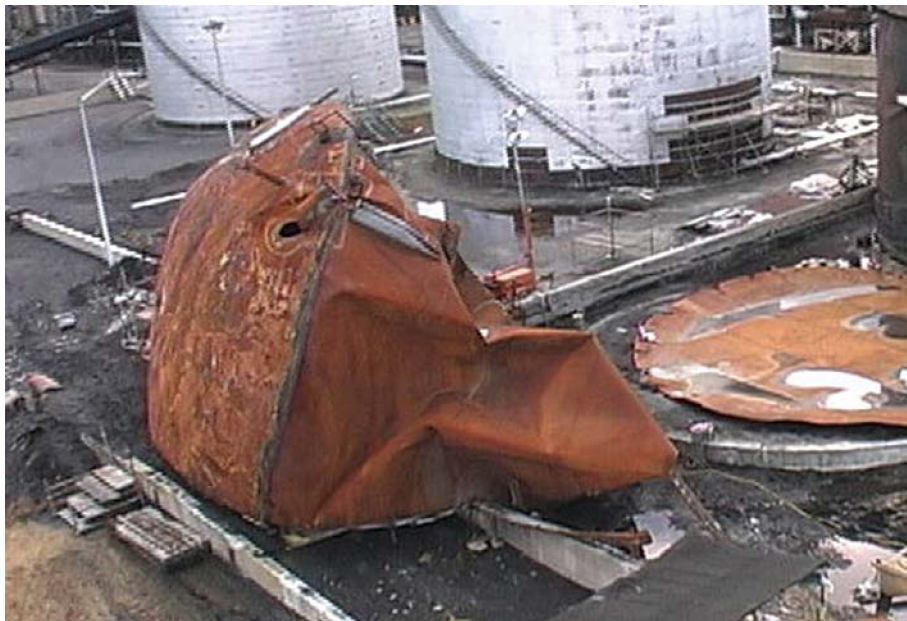
Figure 7.4 Sulfuric acid tank is destroyed during catwalk maintenance. Note the tank floor to the right and the fact that the typical weak roof design failed. Courtesy of Chemical Safety Board Report 2001-05-I-DE.

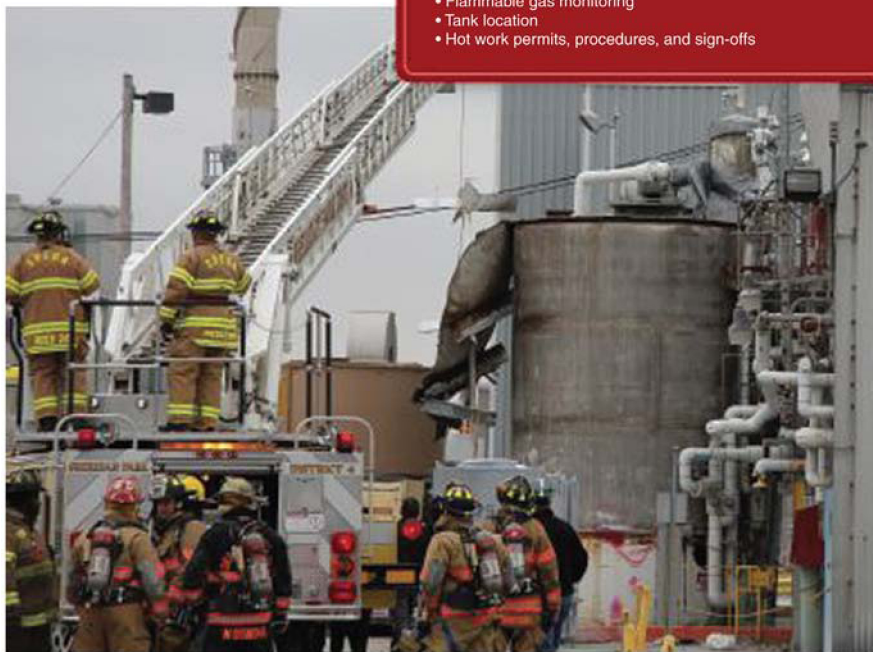
Figure 7.7 This photo captures the emergency team response to DuPont incident. It also shows how the explosion peeled the tank top away from the vertical vessel. Courtesy of Chemical Safety Board [11].

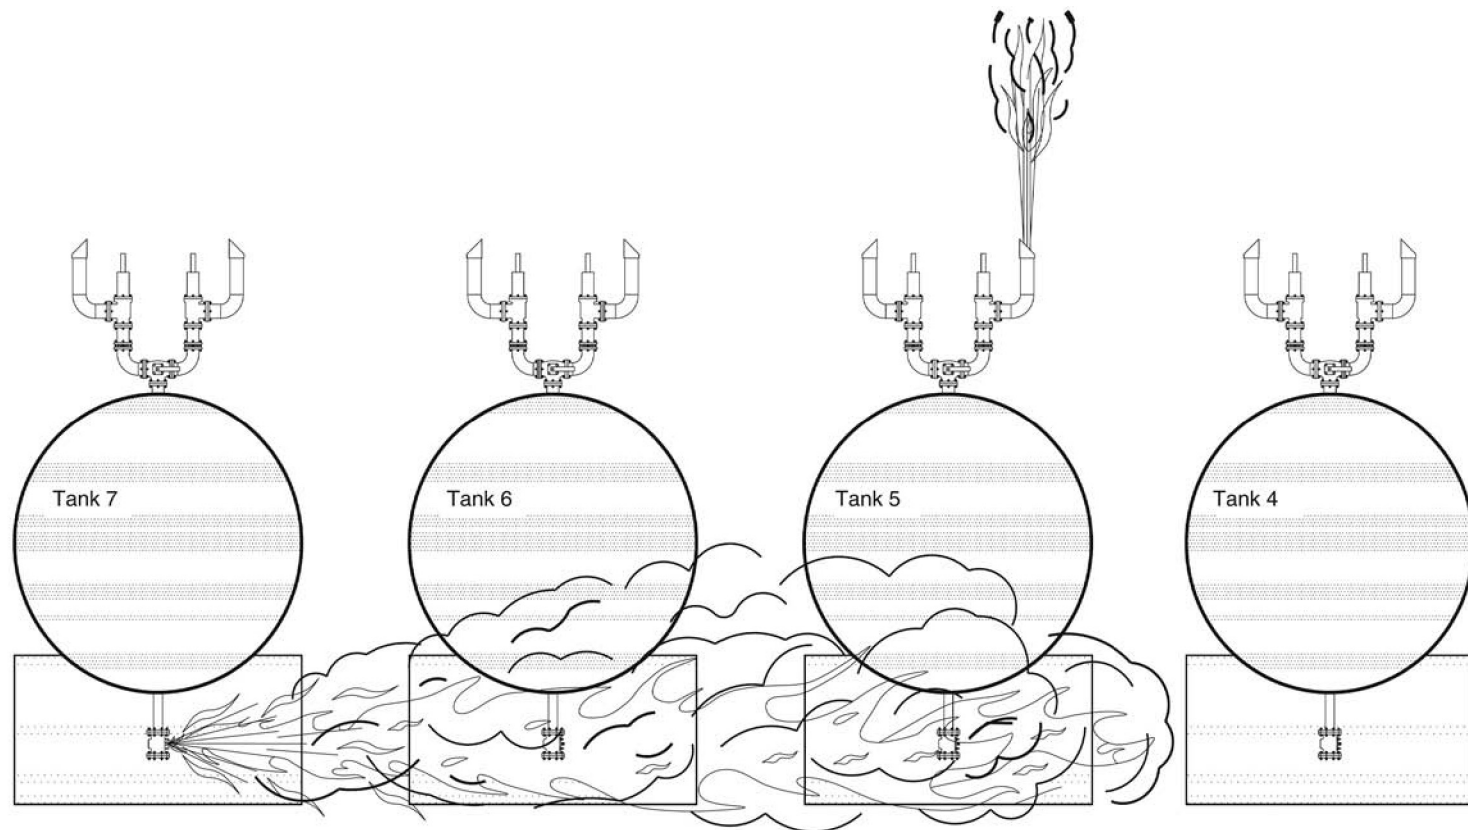
Figure 7.14 Torch-like flames burn below vinyl chloride storage vessels – an artist perception.
Sketch Courtesy of Manuel David.

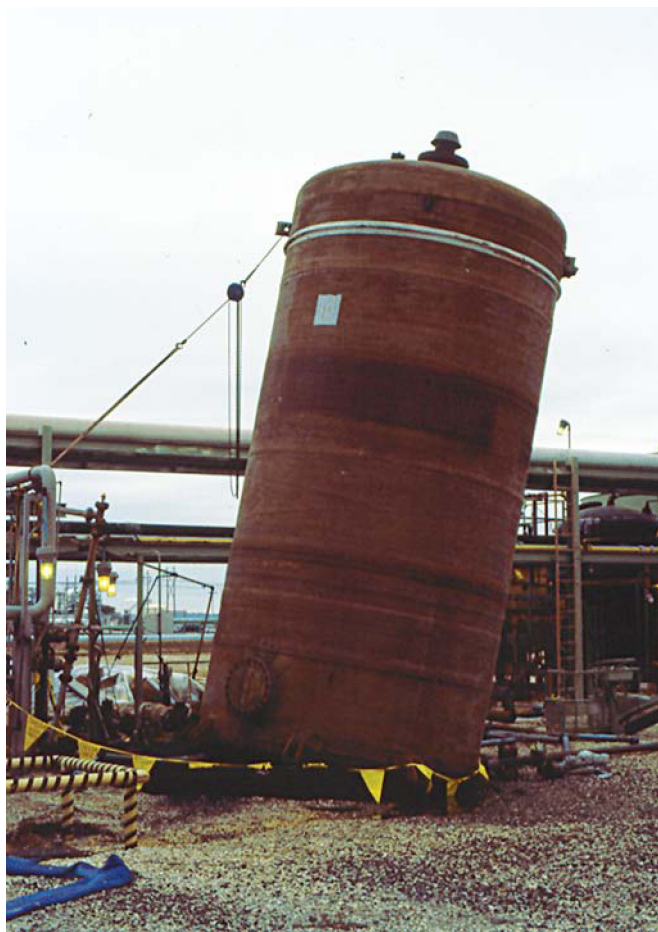
Figure 7.16 A large fiberglass acid tank fails due to blinded vent line and blinded overflow line.

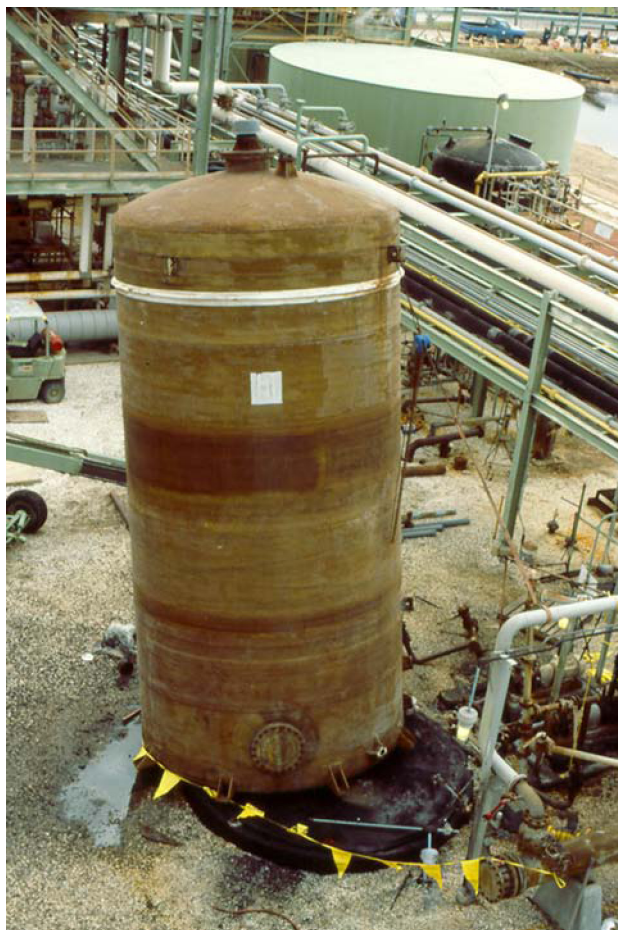
Figure 7.17 An aerial view of the large fiberglass acid tank failure at the floor.

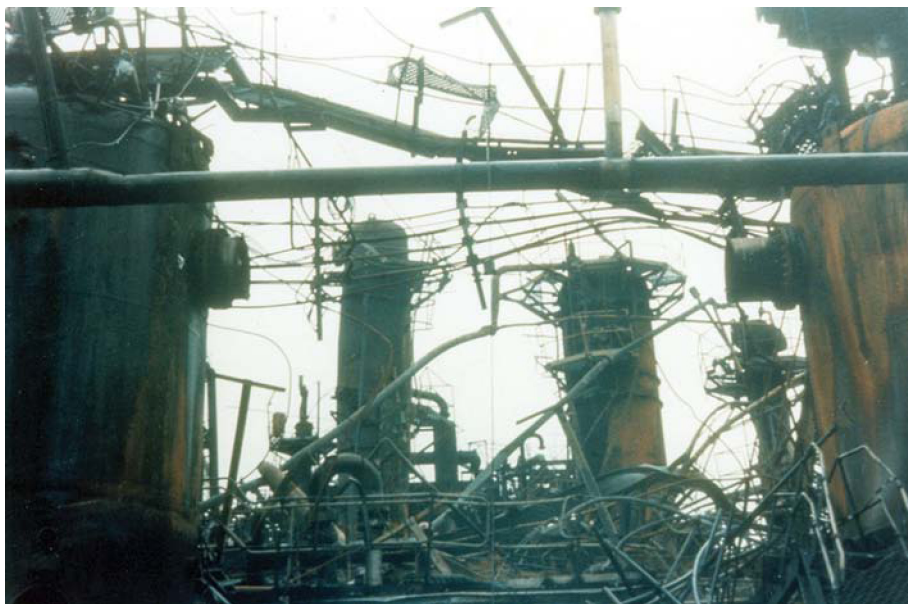
Figure 7.20 A destroyed section of the Flixborough reactor system.
Photo Courtesy of Trevor A. Kletz.

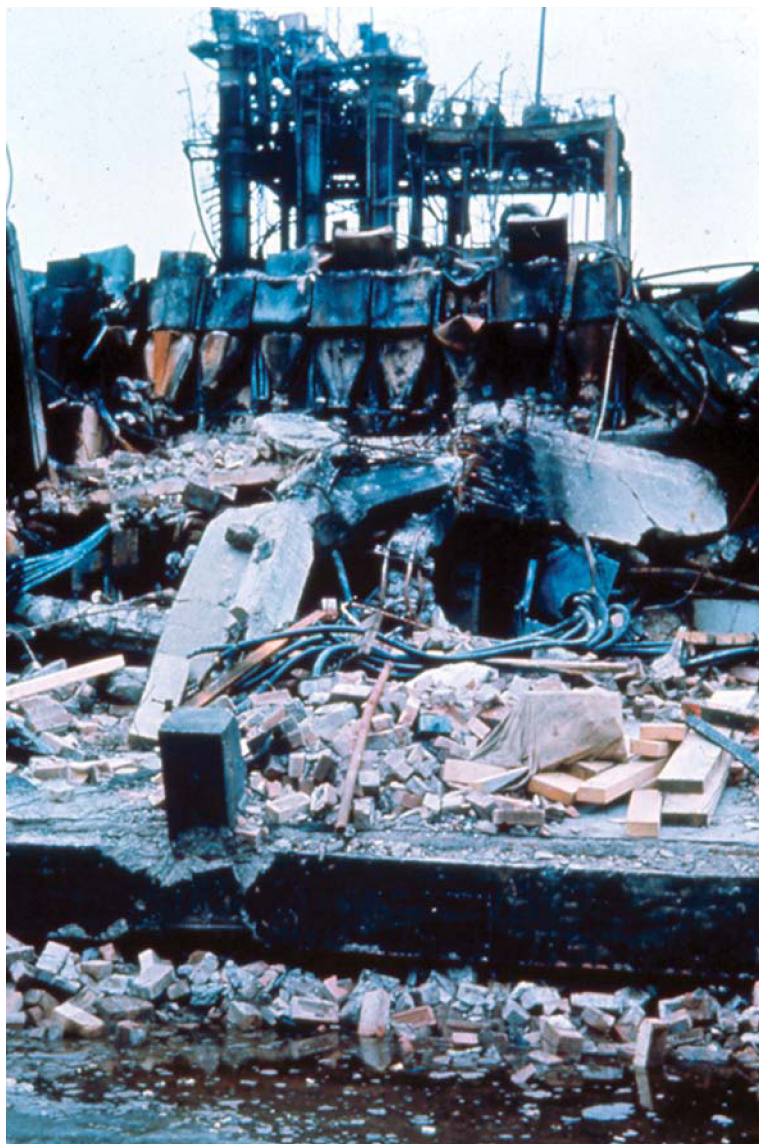
Figure 7.21 The rubble of the crushed control room at Flixborough.
Photo Courtesy of Trevor A. Kletz.

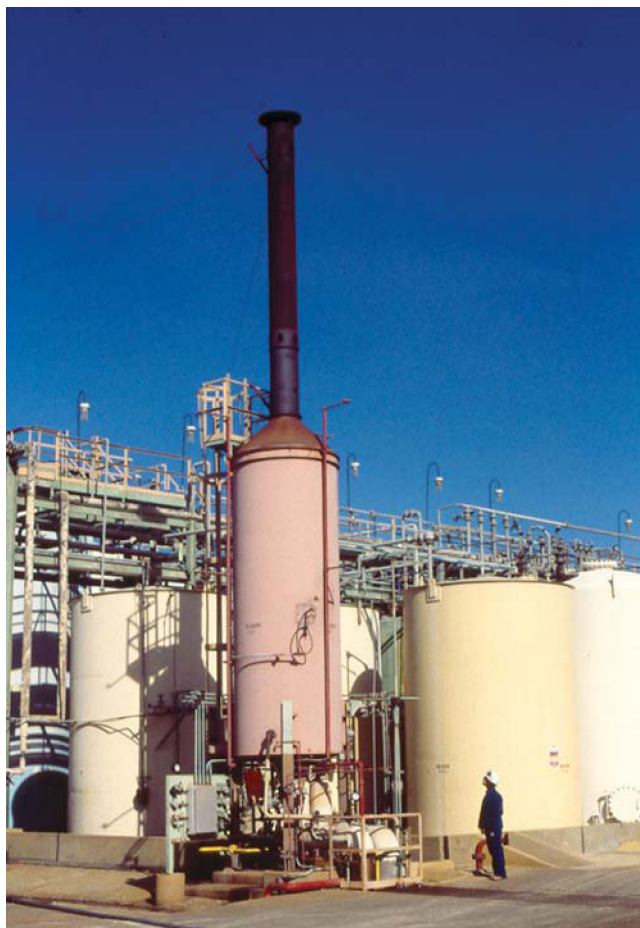
Figure 8.5 The re-built gas-fired heater was relocated away from the process area and the hard to replace process equipment and instruments.

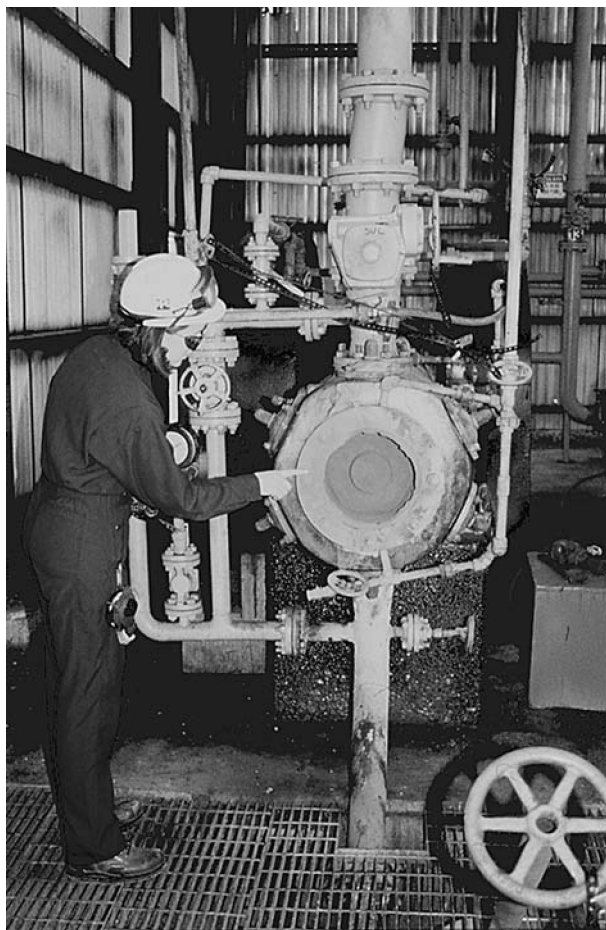
Figure 9.2 The water cooled head of a reciprocating compressor ruptured after the compressor ran for 5 hours with the cooling water blocked-in.

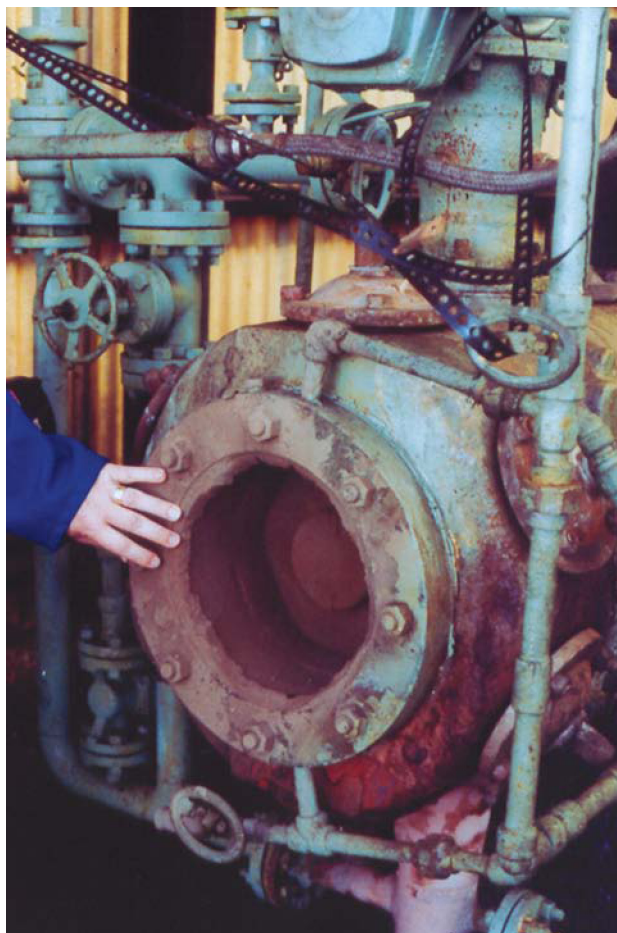
Figure 9.3 Close-up of the ruptured reciprocating compressor water jacket head.

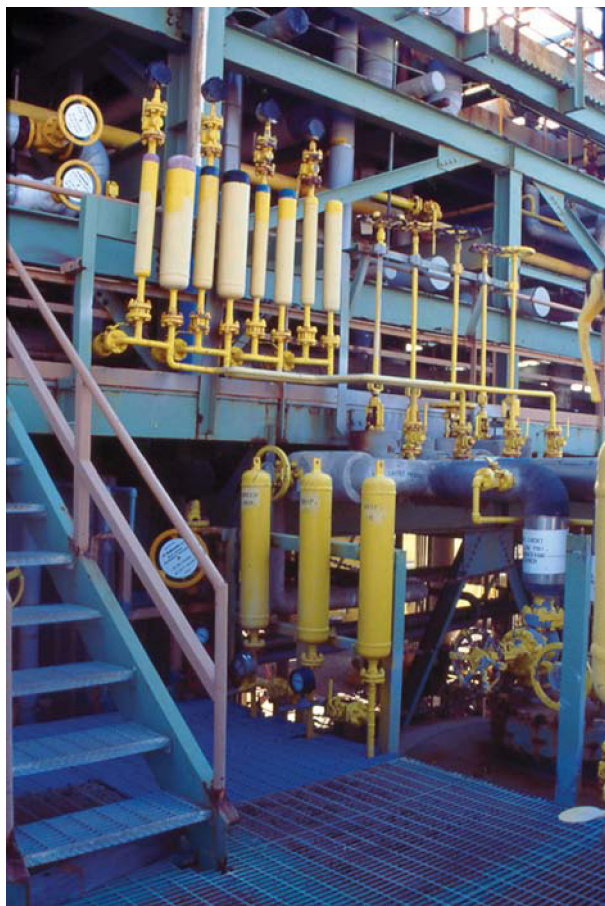
Figure 9.7 Chlorine expansion bottles per the chlorine institute protecting chlorine transfer piping from overpressure.

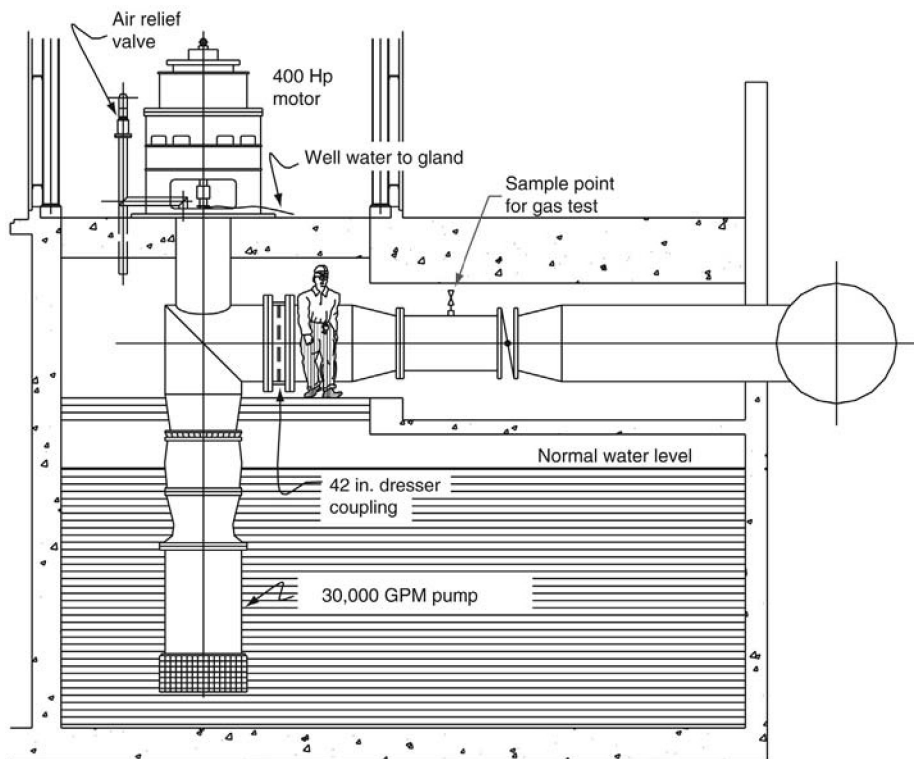
Figure 9.10 Sketch of the river water pump system details at normal conditions. Sketch provided by Manuel David.

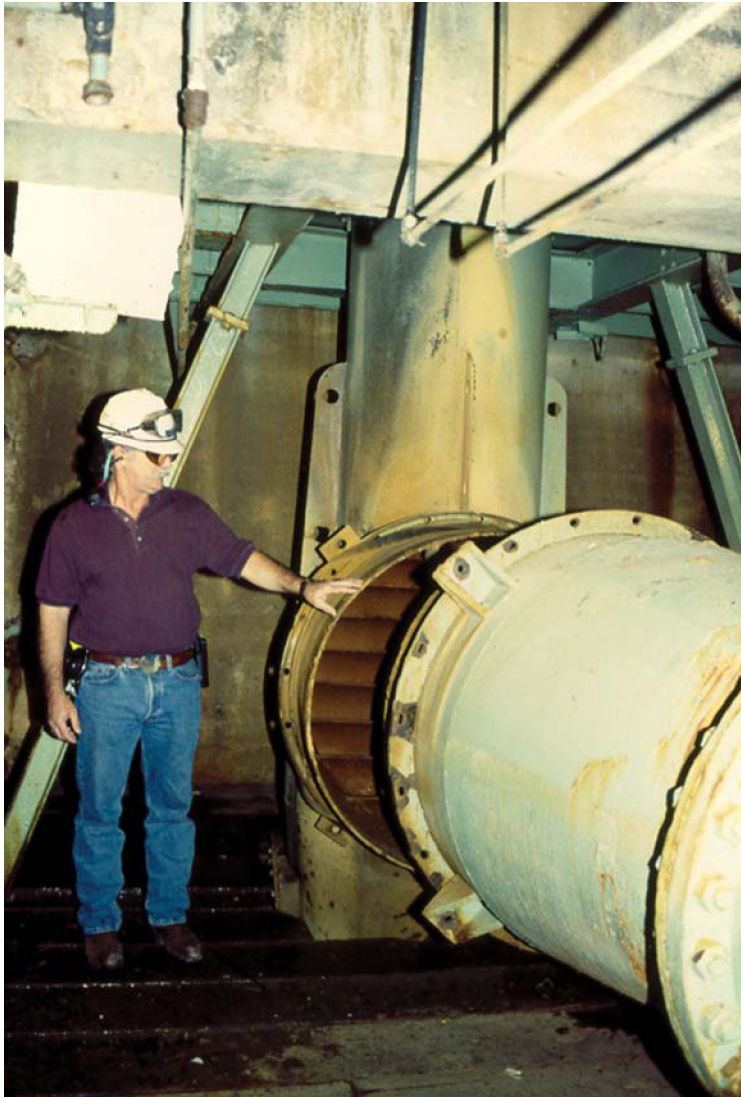
Figure 9.11 The force of the explosion thrust the base plate backwards and knocked the piping out of alignment.

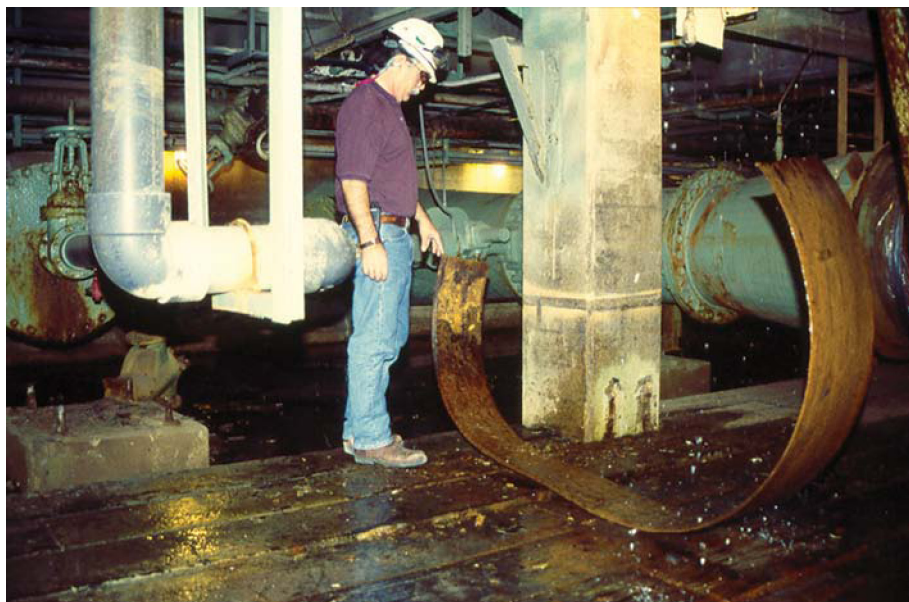
Figure 9.12 The force of the explosion reshaped and straightened a portion of the 42 in. diameter Dresser coupling.

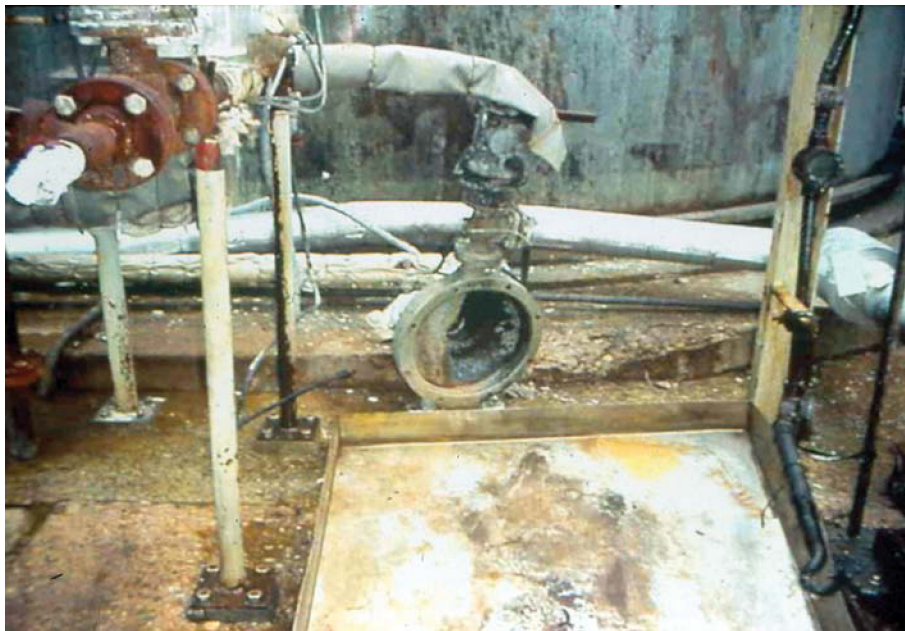
Figure 9.14 Pump bowl is stripped of the pump and base plate.
Courtesy of Eastman Chemical Company.

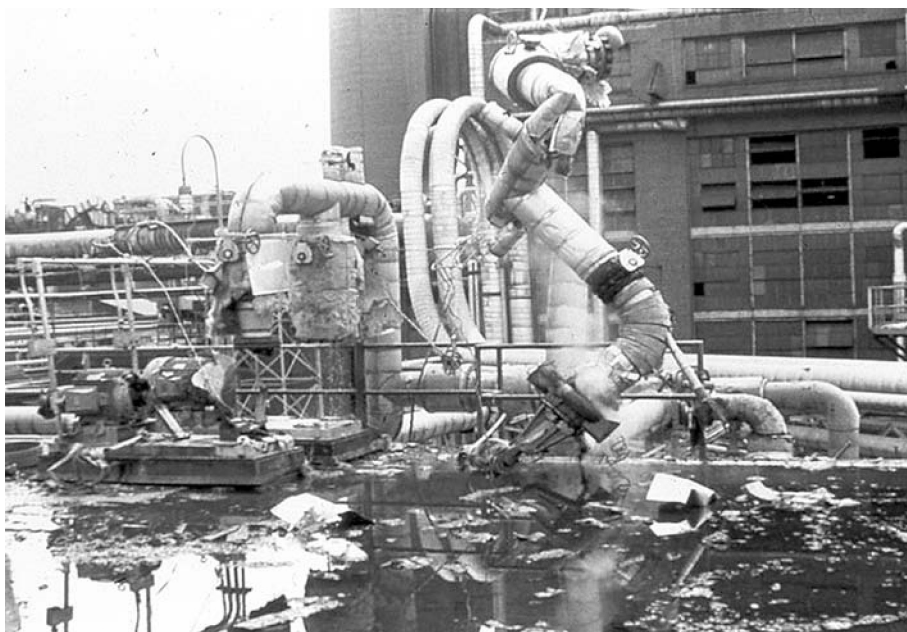
Figure 9.17 Condensate pump installation heavily damaged after operating with the suction and discharge valves tightly shut.
Courtesy of Eastman Chemical Company.

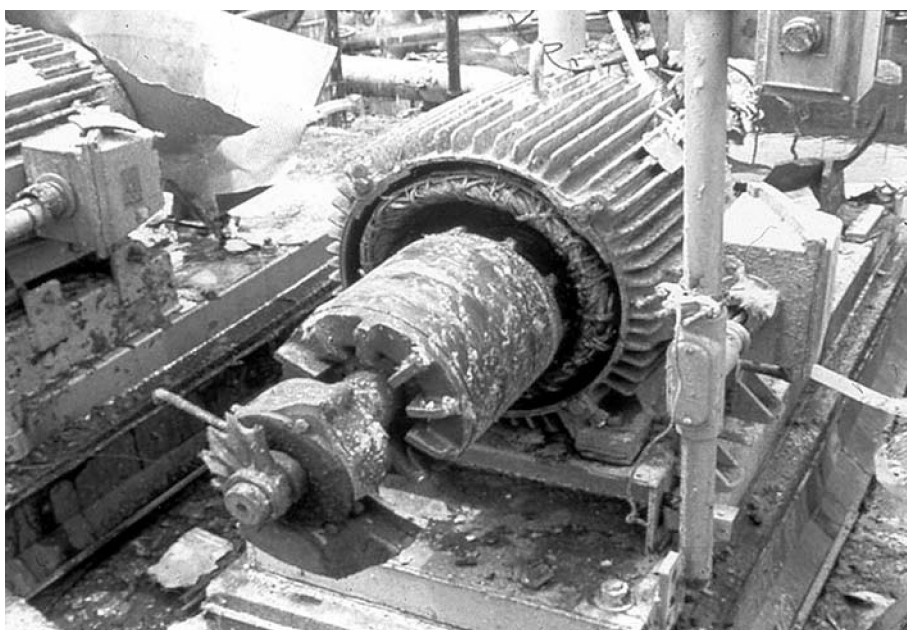
Figure 9.18 Condensate pump motor destroyed. The explosion knocked the rotor assembly out of the 75 Hp pump motor.
Courtesy of Eastman Chemical Company.

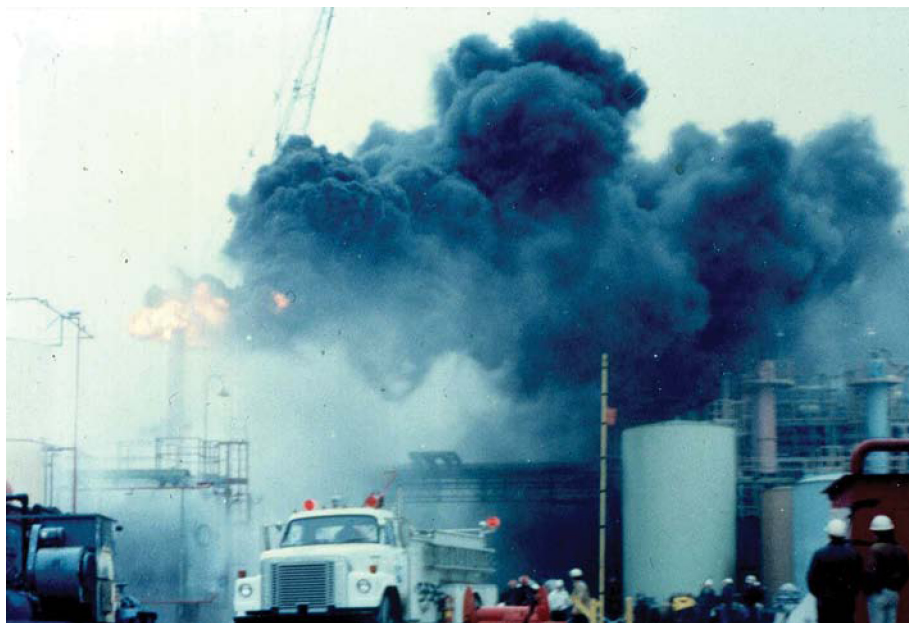
Figure 10.2 Fired heater tubes frozen – improperly thawed – tubes ruptured – heat transfer fluid burns – emergency squad responds.
