CHEMICAL PROCESS SAFETY

— LEARNING FROM CASE HISTORIES —

ROY E. SANDERS

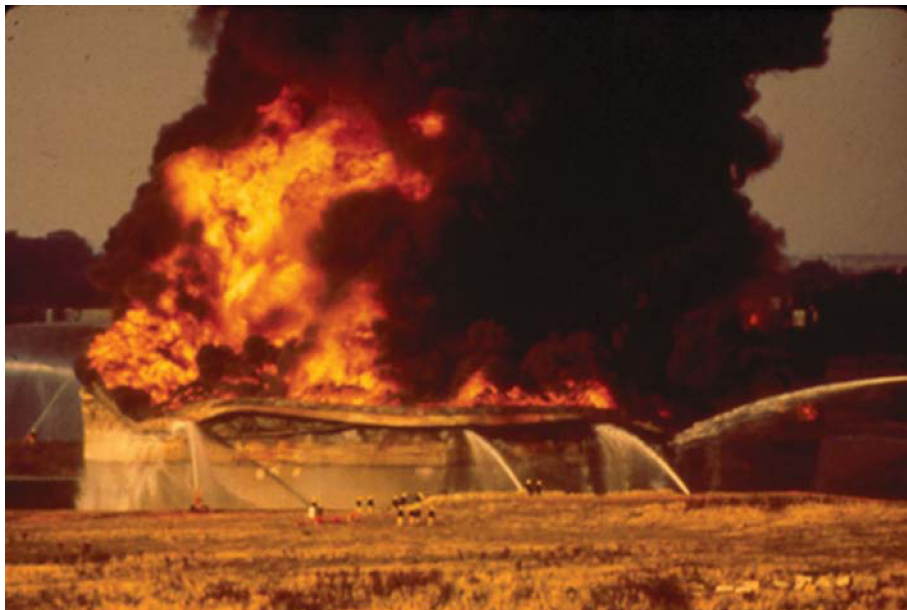
Figure 10.4 A huge tank fire confined by tank walls. This gigantic vessel is about 100 meters in diameter and after the fire started the burning liquid remains contained. Look hard and you will see at least eleven firefighters near the vessel attempting to control the blaze. Courtesy of the Institution of Chemical Engineers – from Hazard Workshop No. 3, “Fires and Explosions [8].”

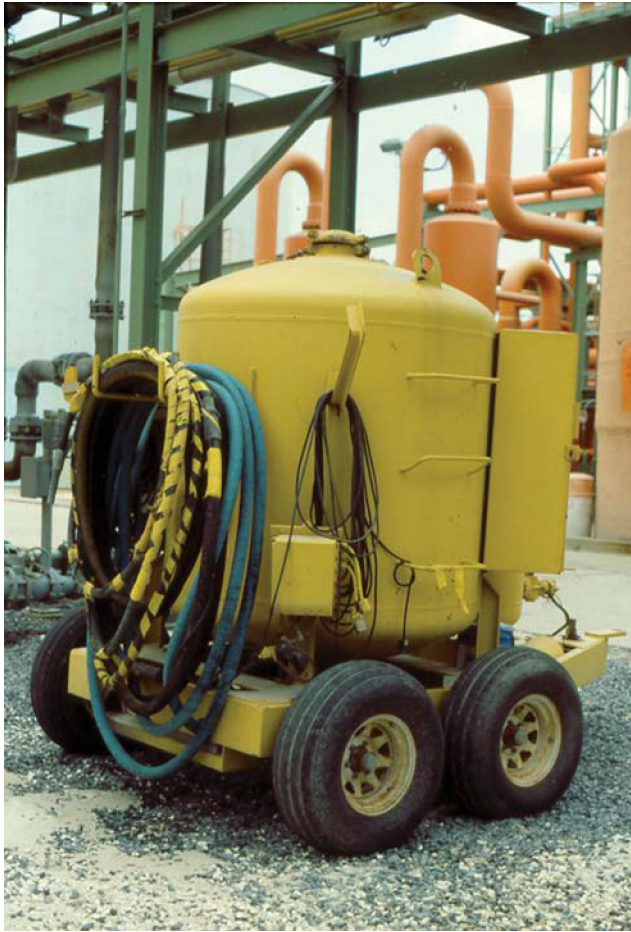
Figure 10.6 Repairs to a portable sandblast pot did not meet specifications and the lid pops off.

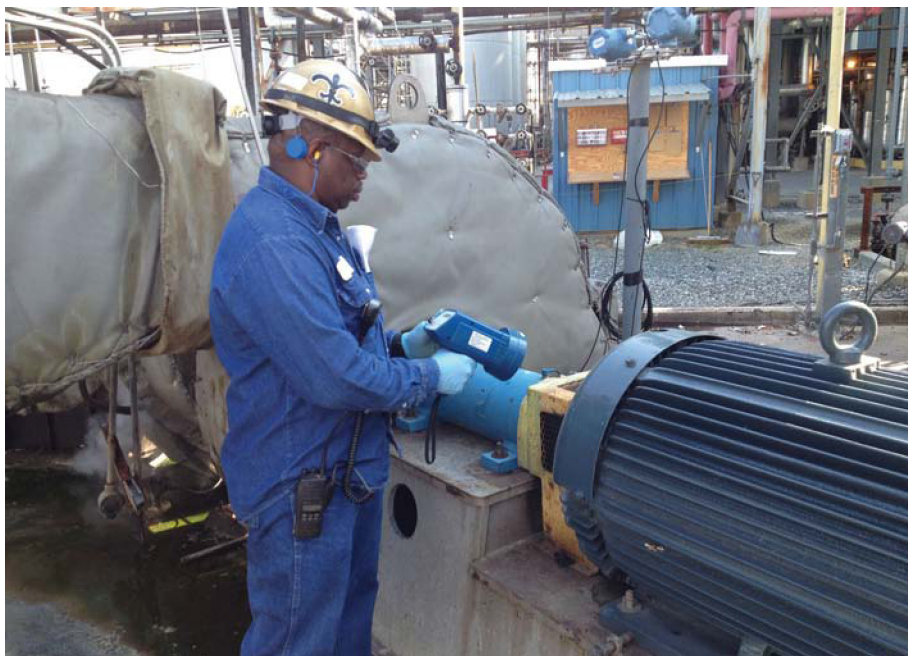
Figure 12.4 A mechanic is inspecting a blower coupling condition and alignment using a timing light at a specialty chemical facility.

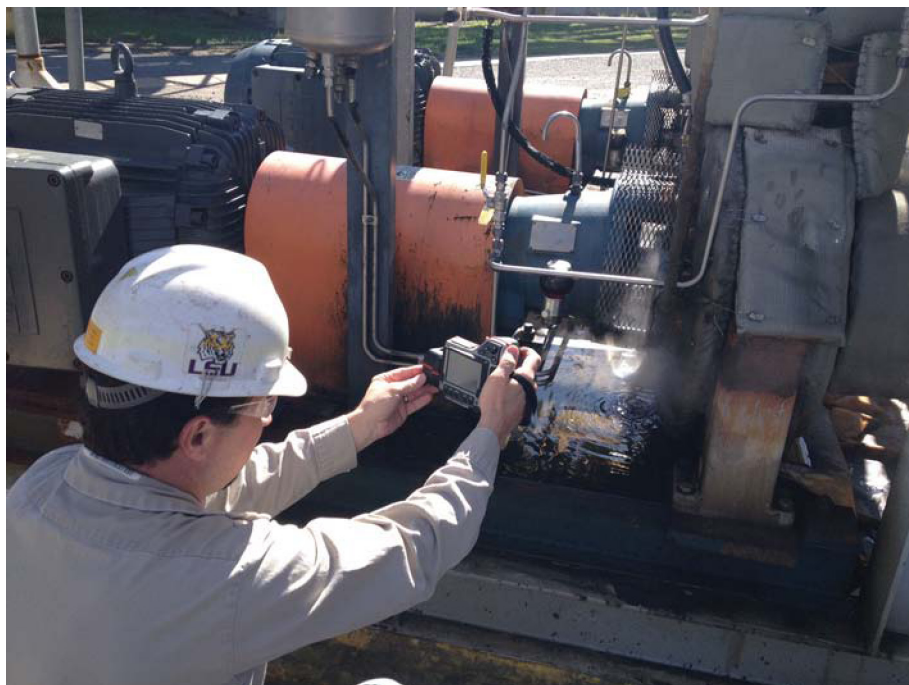
Figure 12.5 Thermography survey – an engineer taking infrared readings on a hot oil pump including a look at the bearings and the insulation.

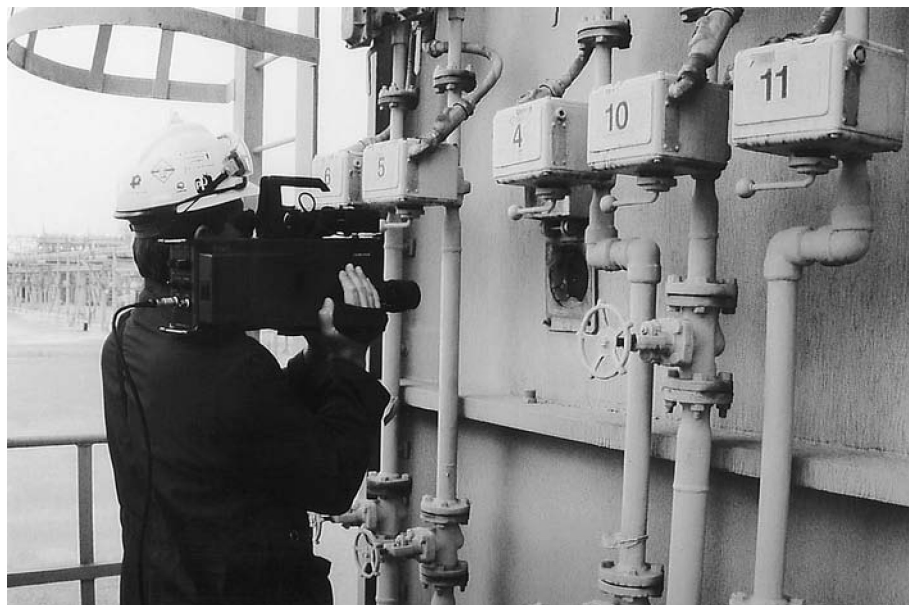
Figure 12.6 An Inspector uses an infrared camera to periodically monitor furnace tube temperatures via the port holes. The objective is to look for potential hot spots which will indicate coking within the tubes and damage to the tubes.

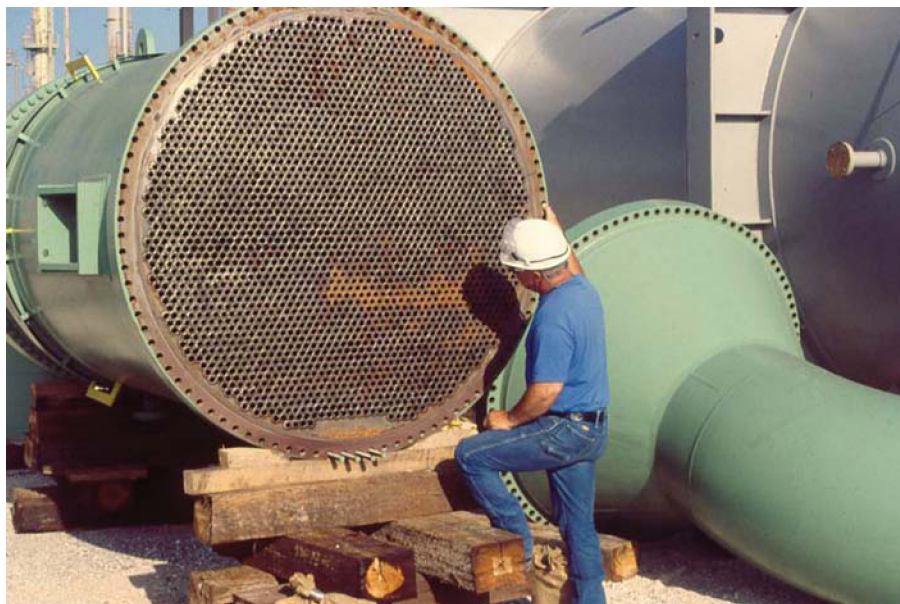
Figure 12.8 Qualified equipment inspectors play a key role inspecting equipment during fabrication in shops and after they are delivered. Here an inspector examines a retubed heat exchanger when it arrived at the plant site.

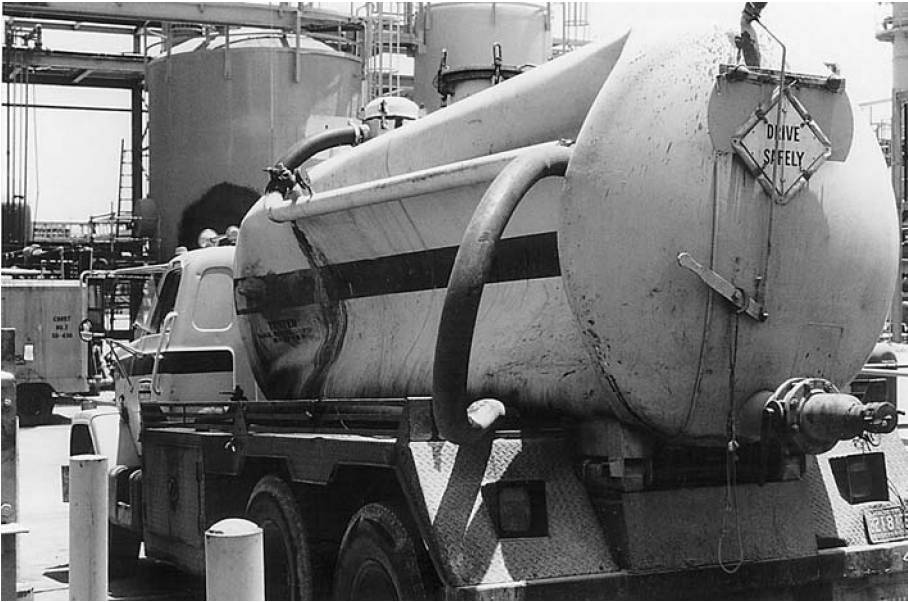
Figure 12.14 A collapsed service company vacuum truck tank signals an inadequate mechanical integrity program.

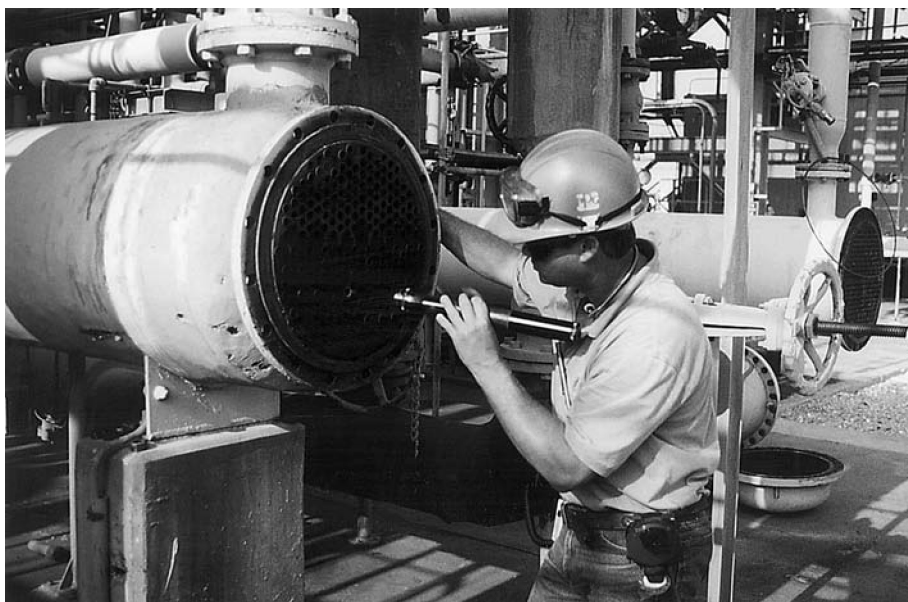
Figure 12.16 An inspector examines the condition of the tubes on a condenser during an outage. Water side corrosion can occur if the cooling water treatment is insufficient.

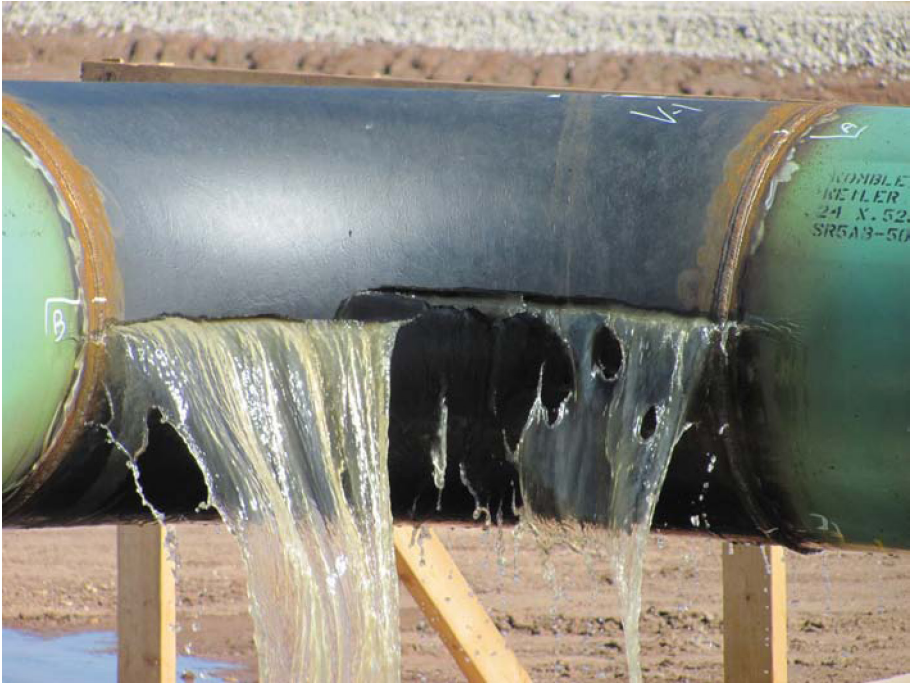
Figure 12.18 A close-up of the inferior, poorly manufactured 24-in. piping elbow which failed during a routine hydrotest.

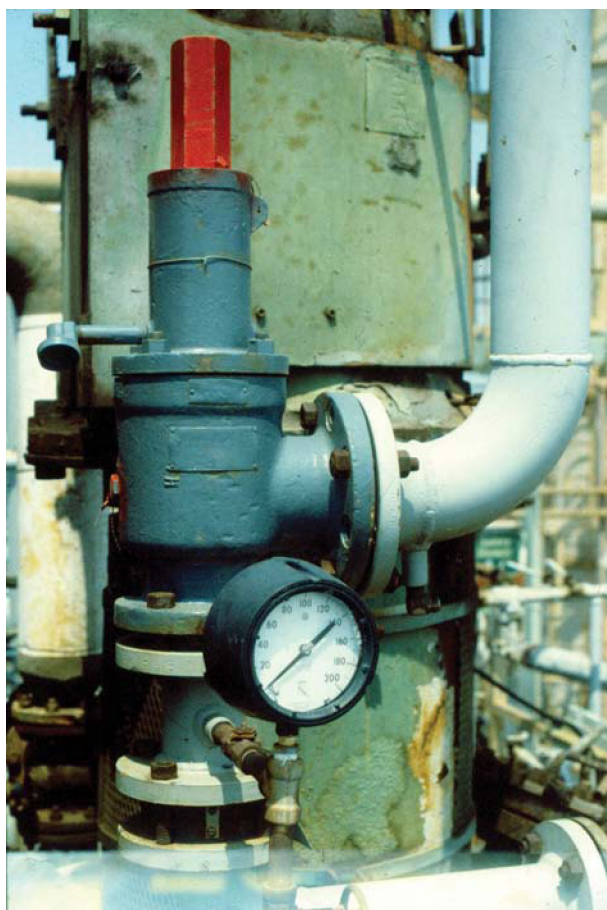
Figure 12.19 A typical safety relief valve, SRV, and rupture disc combination for a chemical process vessel. The rupture disk protects against the metal-to-metal seats on the SRV from seeping. The pressure gage lets you know if the rupture disk has “popped” or is leaking. The space between the rupture disk and SRV is required to be monitored by the ASME Code.

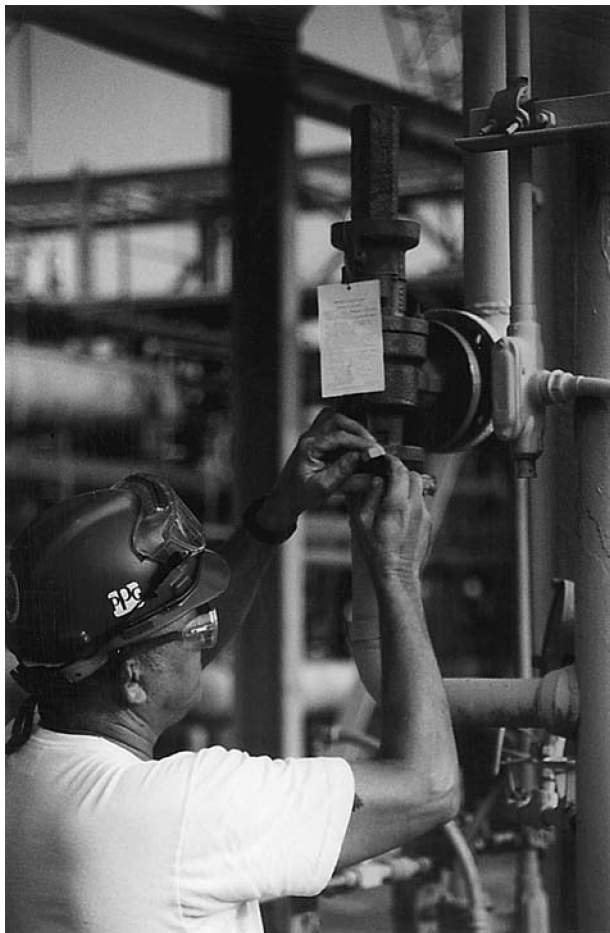
Figure 12.22 A mechanic is removing an SRV from a protected site in the unit. The mechanic records the condition of the inlet and the outlet piping components on an attached tag before the valve is sent for testing.
